The causes and prevention of human error contributing to maritime accidents in Tanzania

**THE CAUSES, AND PREVENTION OF HUMAN
ERROR CONTRIBUTING TO MARITIME
ACCIDENTS IN TANZANIA.**

GERSON JAPHET FUMBUKA

Title of Dissertation: The Causes and Prevention of Human Error contributing to maritime accidents in Tanzania.

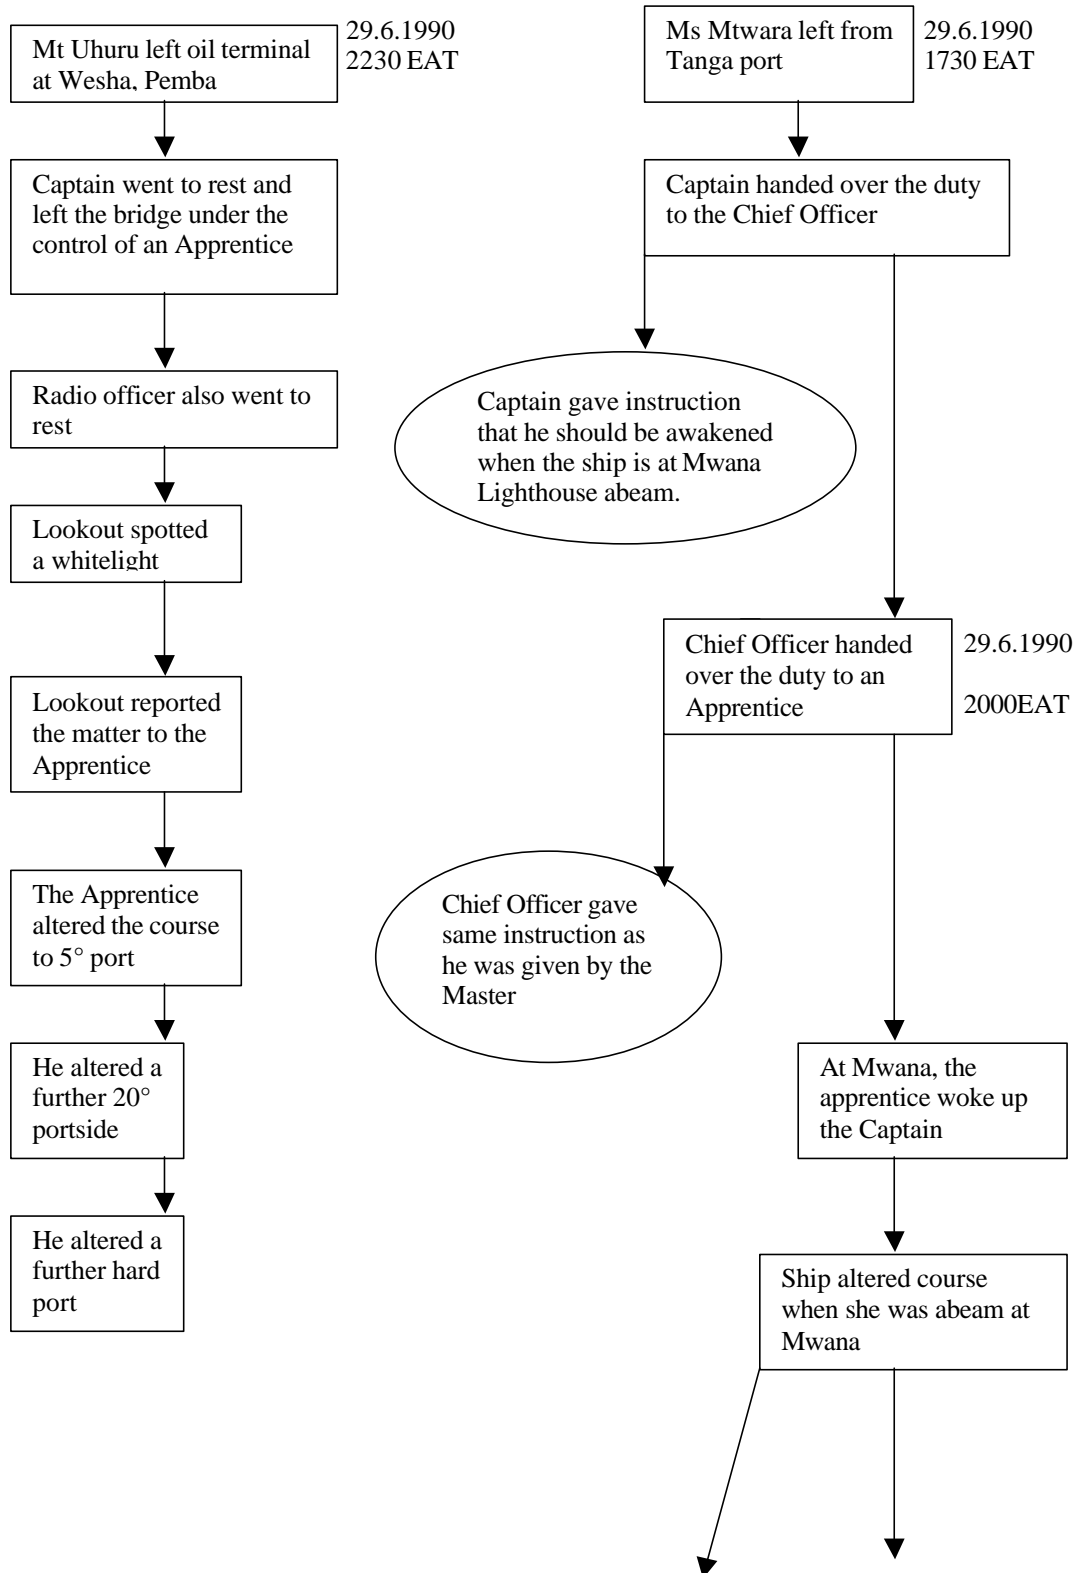
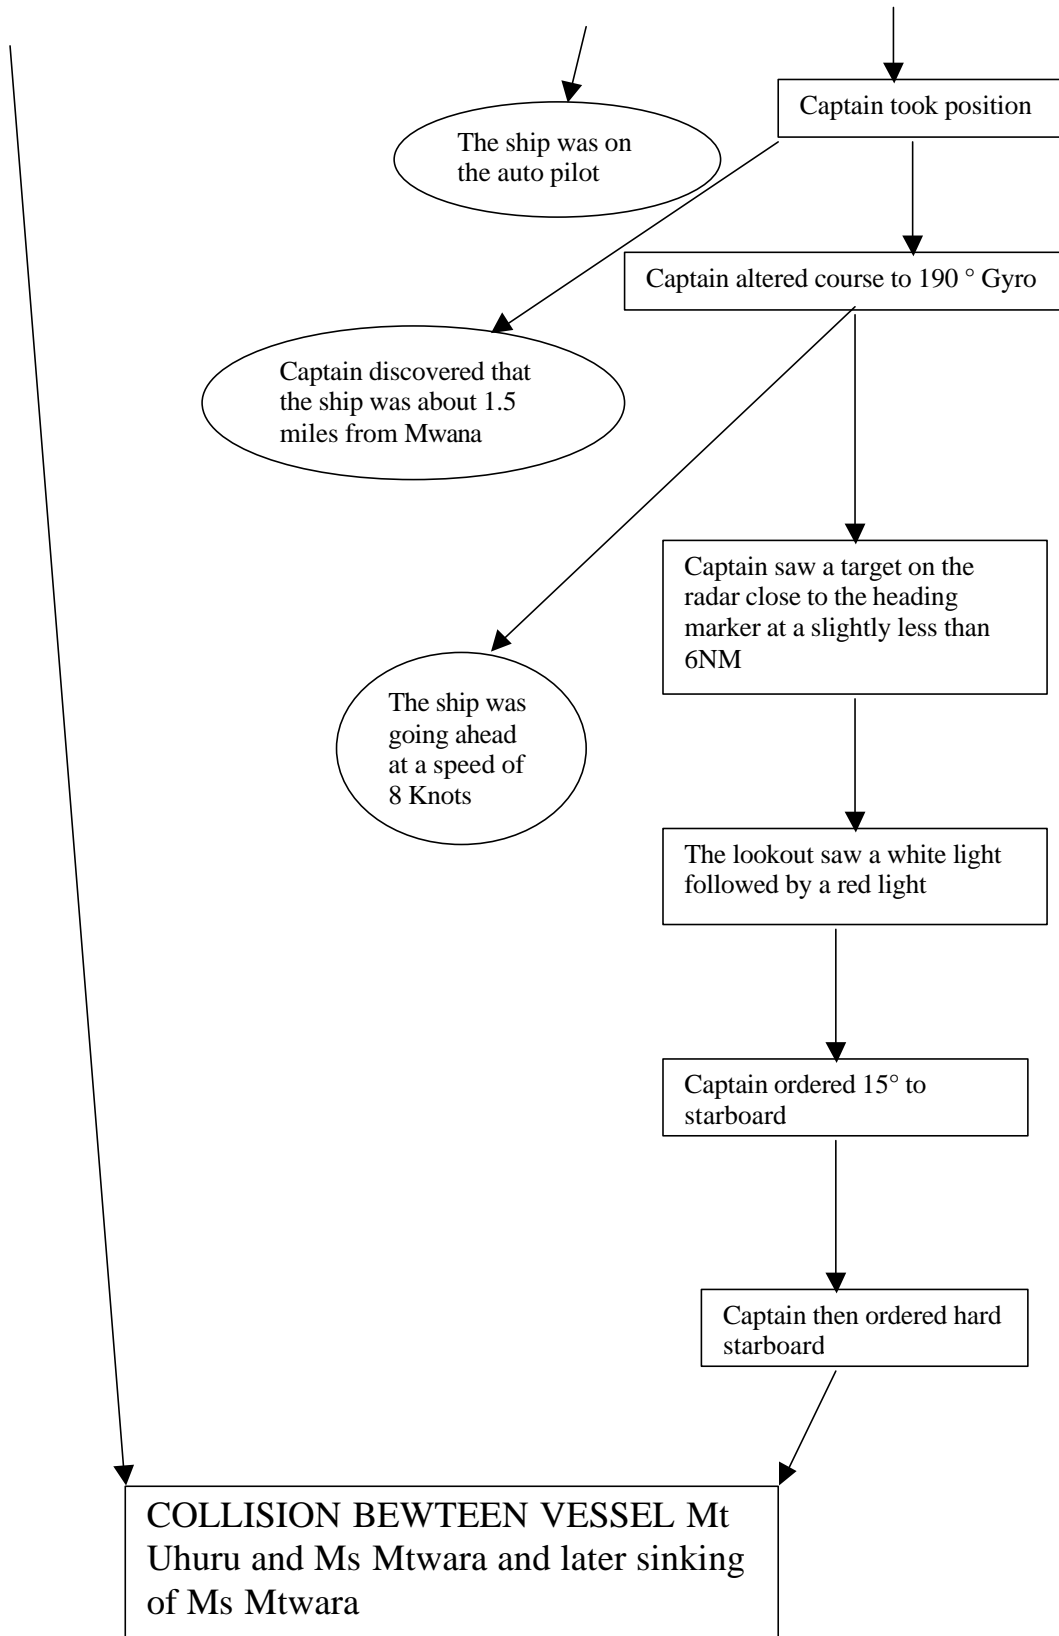
(Chart 1.0) Events and Causal Factors Analysis of the collision between tanker vessel Mt Uhuru and Passenger vessel Ms Mtwara

side of their intended courses. The MT Uhuru hit the MS Mtwara just aft of the portside door at the tween deck level. A few minutes later MT Uhuru substantial damage but did not sink.

The signal station failed to mention that MT Uhuru had left Zanzibar. The apprentice was unable to determine the location of the vessel MS Mtwara just before the collision. His lack of knowledge, training, and experience in commanding a vessel prevented him from making proper judgement in altering to port instead to starboard in accordance to COLREG 1972.

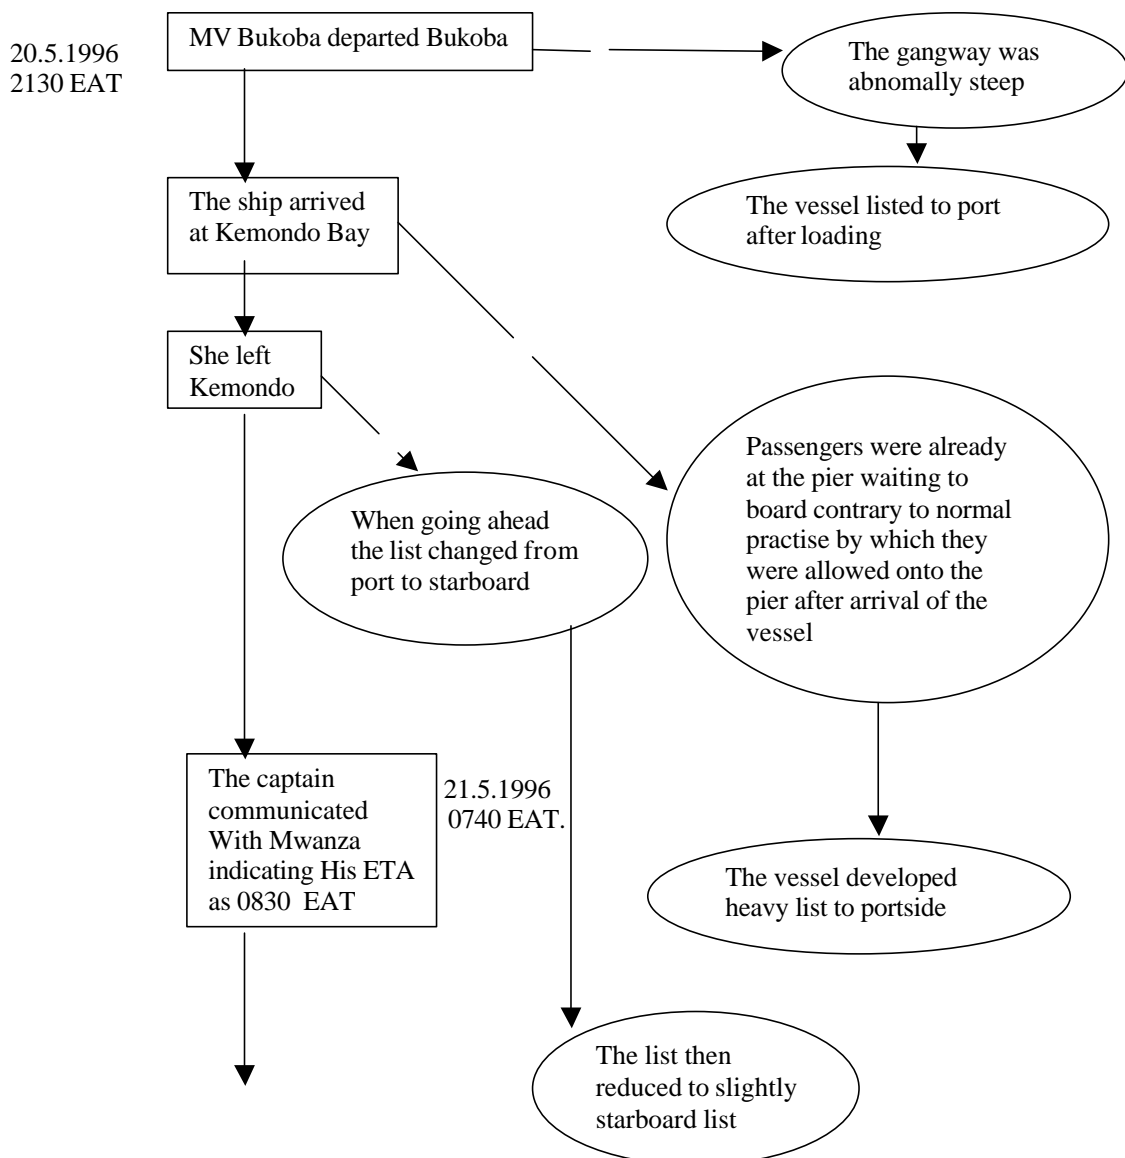
(Chart 2.0) Events and causal Factors Analysis of the Capsize of MV Bukoba

It has been determined that MV Bukoba capsized due to stability deficiency.

It was generally observed that MV Bukoba was listing slightly to port or starboard during her lifetime. Although the cause of list was not investigated on board the vessel, it is evident that it was either due to poor design or construction or both. Basically, TRC acquired a faulty ship from Belgium Shipbuilders Corporation (BSC) whose defects could not be detected for sometime until Danish expert came on the scene three years later. This problem originated from the contract itself which was drawn by the ship builders, and was heavily skewed in favour of the shipbuilders. The belgian party was adamantly reluctant to vary any of the terms in the contract inspite of numerous appeals from the Government of Tanzania. Due to the special circumstances prevailing at the time, especially the transportation crisis with the Government's financial weakness, the Tanzania Government apparently felt itself to have no option but to accept the unequal terms of the contract. Here are some of the contract articles which had serious anomalies:

1. MV Bukoba had a common tendency of listing to the portside or the starboard side.
2. The vessel had two shore communication systems both in good condition but internal communication between engine room and bridge was defective.

3. It was common practise to overload the vessel.
4. There was no stability booklet onboard.
5. Most of the senior officers onboard had no knowledge of ballasting conditions requiring permanent ballasting.

In 1985, the Danish Maritime Institute recommended measures to be undertaken in order to improve stability. Also in 1994, the Embassy of Belgium in Tanzania recommended yet another solution for the improvement of the stability. Two

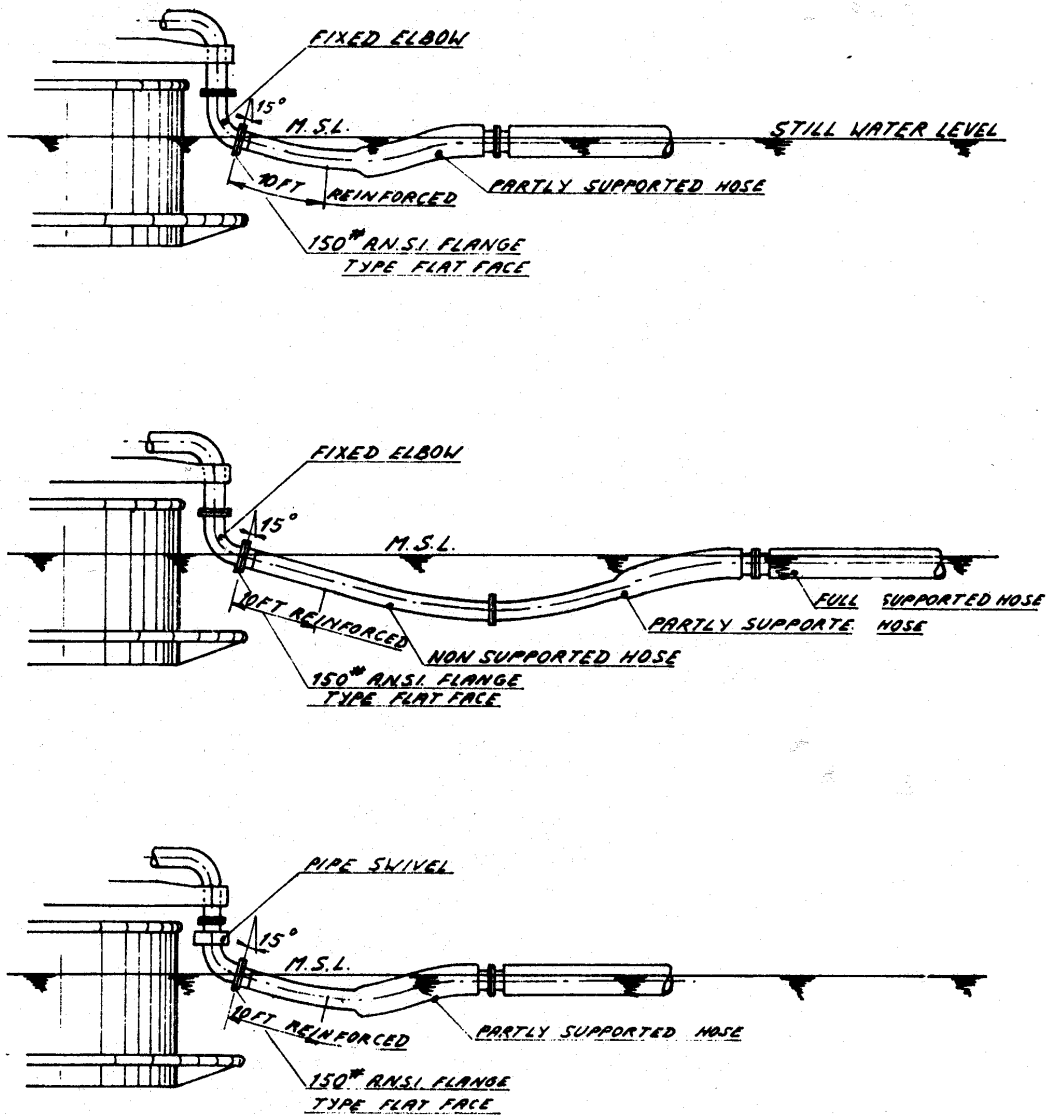
Mooring Master went on leave from 1st December 1996 until 30th December 1996. On 1st December 1996 he handed over his duties verbally to the Assistant Mooring Master on front of Harbour Master and Senior Harbour Master. The Mooring Master left the following assignment to be done on the SBM that is to repair the damaged and worn out floating hose, which was losing ability to float (Figure 3.0).

Figure 3.0 Different arrangements of floating hose
