Improving pilot boarding arrangements to prevent transfer accidents

**IMPROVING PILOT BOARDING
ARRANGEMENTS TO PREVENT
TRANSFER ACCIDENTS**

**A dissertation submitted to the World Maritime University in partial fulfilment
of the requirements for the award of the degree of Master of Science in Maritime
Affairs**

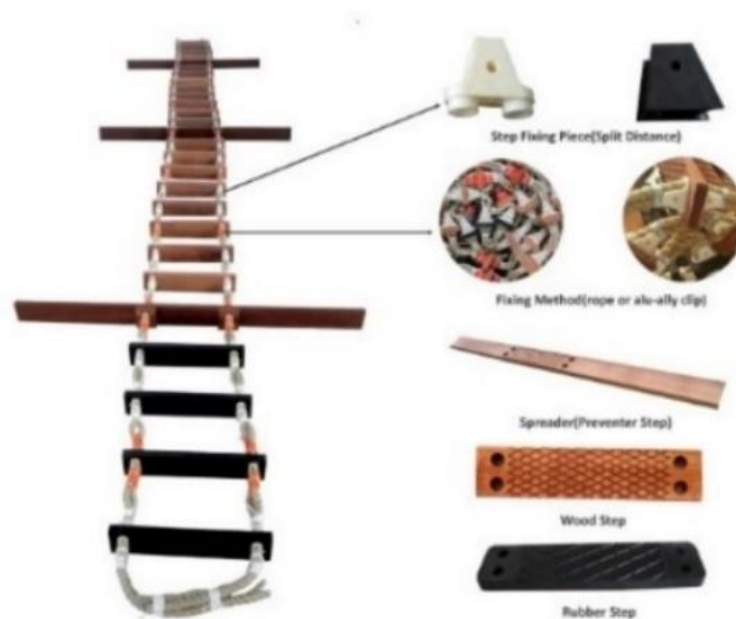
Figure 2

Pilot ladder and its components

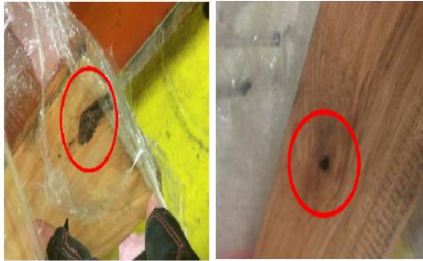
Figure 3

The function of the spreader steps is to prevent the twisting of the pilot ladder, but Kinzo et.al (1998) concluded that the 1.8-meter length of the spreader steps is too short to prevent the twisting of the pilot ladder, especially under the condition that the ship's speed is 4~7 knots, when the wave touches the lower end of the pilot ladder, the pilot ladder will easily twist if no countermeasure is taken based on the results of their experiments. The step and spreader step are made of wood and scar knots can affect their strength (**Figure 3**).

Knots in the steps

IMO (2011) required that if the step is made of hardwood, they should be made in one piece, free of knots.

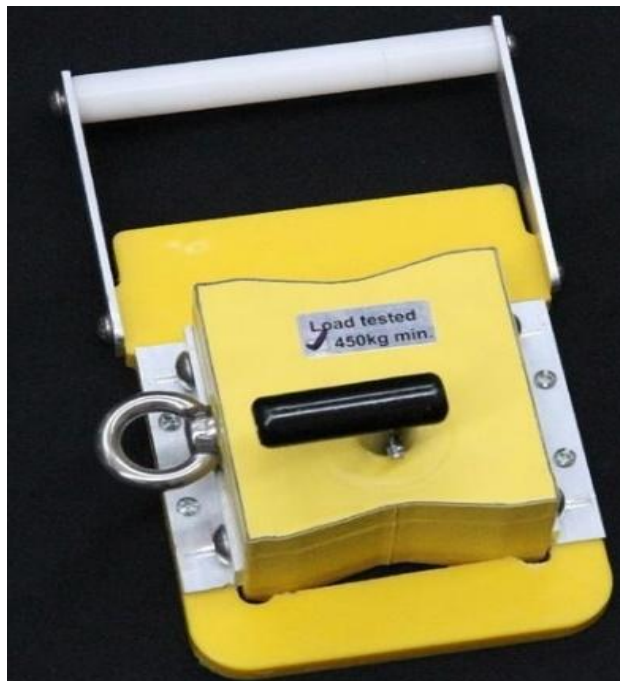
Figure 14

In this design, two preventer wire ropes and holding magnets are used to stabilize the basket when the ship encounters bad weather. The top ends of the preventer wire ropes are secured on the davits and the other ends to the holding magnets. Before arriving at the pilot station, the master should assess the weather and sea conditions. Prepare the preventer wire ropes and holding magnets when the basket is launched at the designated position. The holding magnet can provide 450kgs breakaway strength (Figure 14). Two magnets provide 900kgs breakaway strength, which can effectively prevent the basket from rolling and twisting.

Pilot ladder magnet

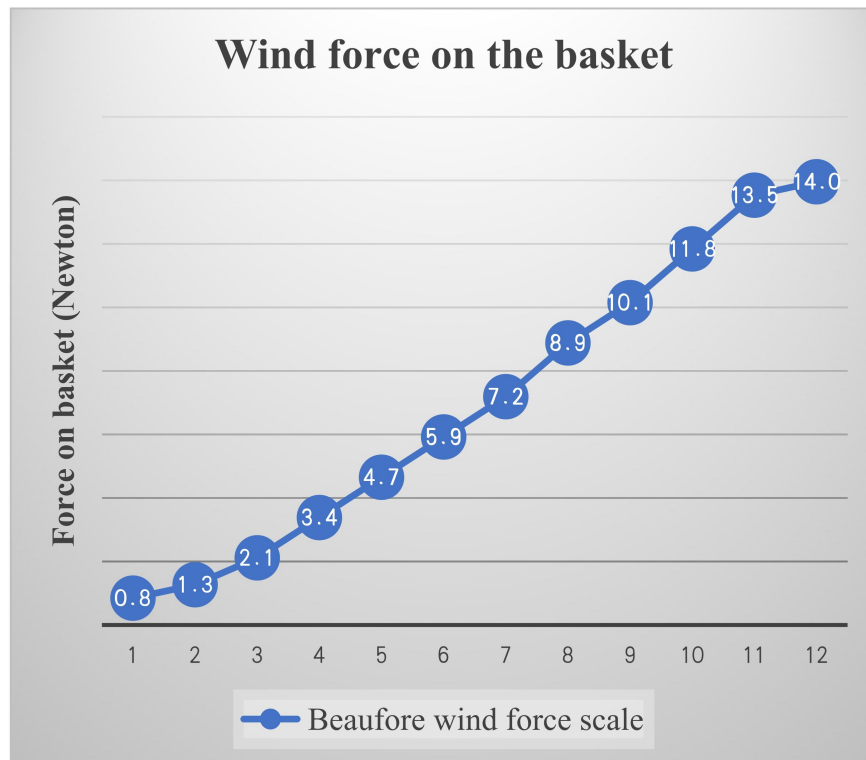
Force on lift basket

Figure 27 shows the effect of wind (from force one to force twelve) on the basket, ranging from 0.8 Newtons to 14 Newtons. While one magnet provides 4415.5 Newtons ($450\text{kg} \times 9.81\text{N/kg}$) of holding force (**Figure 28**), this is obviously more than 14.0 Newtons. This means that the basket will not roll and twist under this situation.

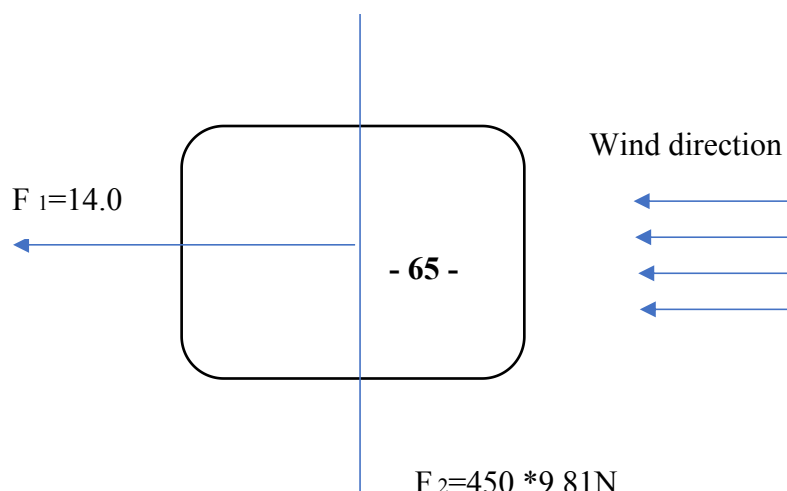
Figure 28

Mechanical analysis (wind)
