The causes and prevention of human error contributing to maritime accidents in Tanzania

**THE CAUSES, AND PREVENTION OF HUMAN
ERROR CONTRIBUTING TO MARITIME
ACCIDENTS IN TANZANIA.**

GERSON JAPHET FUMBUKA

Title of Dissertation: The Causes and Prevention of Human Error contributing to maritime accidents in Tanzania.

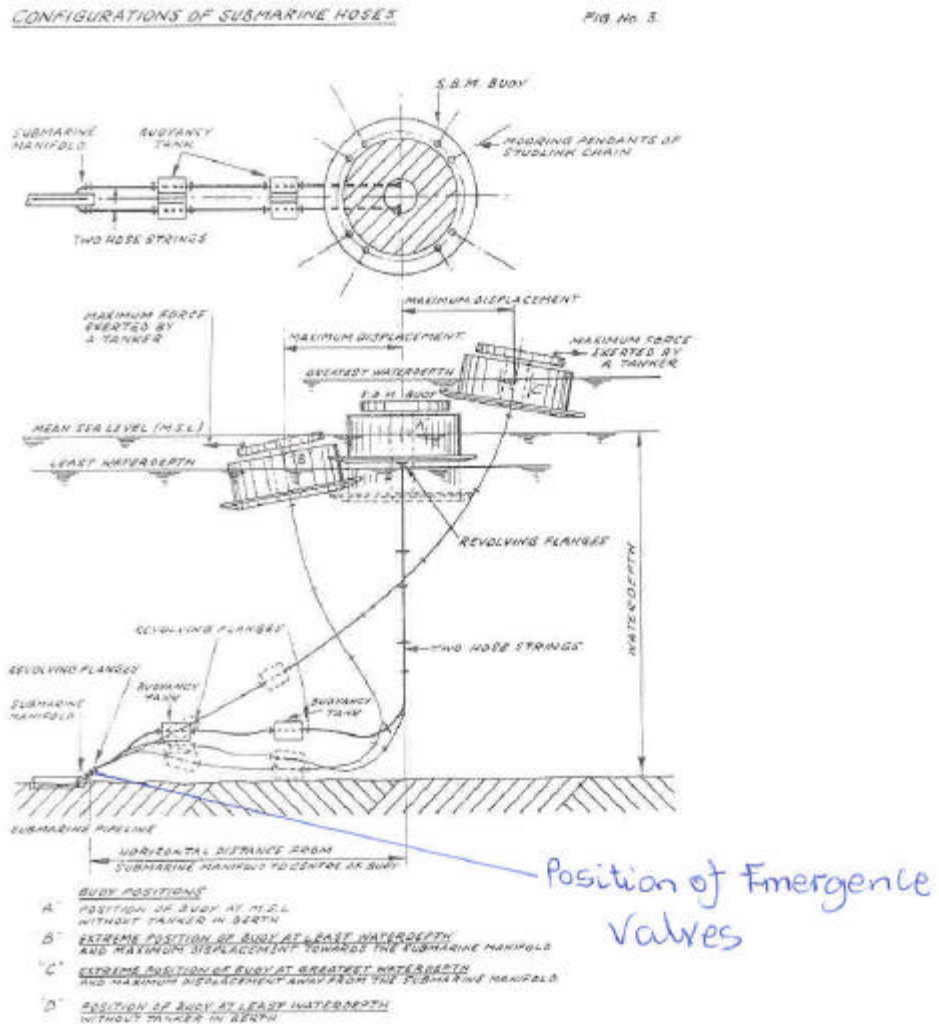
Figure 3.2 Position of Emergence valves

The team returned to the SBM and found oil spillage all over the place. The divers initiated their way down to close the Cameroun valve or emergence valves (Figure 3.2). When they were closing it, the lock pin of the handle was broken. It must be noted that it takes 20 to 30 minutes for three people to close that valve when working on the land surface. While in the water it takes more time to close it. They decided to take the handle of the valve for repair at the dockyard and reported the matter to the acting-mooring master.
