Fire protection onboard : enhance fire safety by design

FIRE PROTECTION ONBOARD

Enhance Fire Safety by Design

ZHANG SHANGCHUN

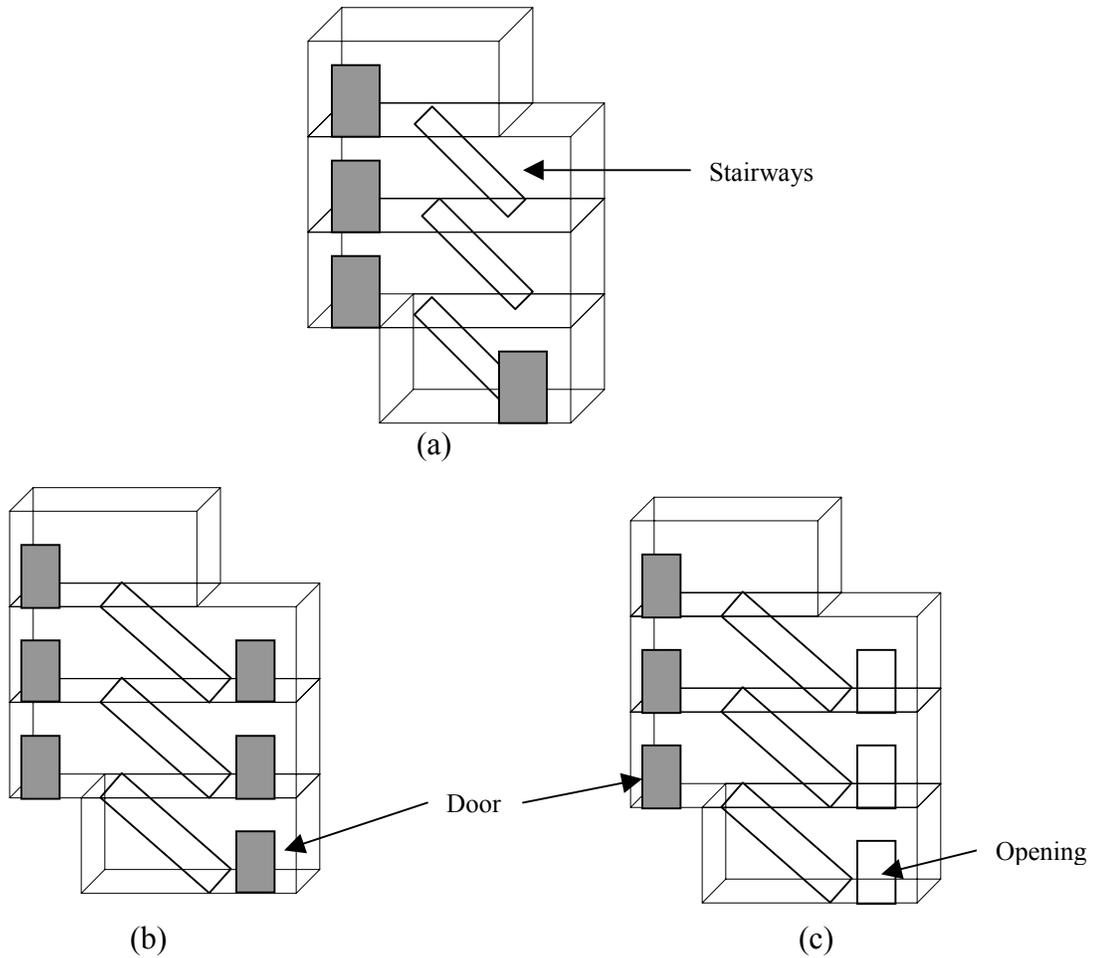
Figure 4.1

IMO Maritime Safety Committee accepted three methods of enclosing stairways, which are shown in Figure 4.1, as complying with the regulations in the 1981 SOLAS Amendments relating to the enclosing of stairways serving more than two decks.

There is no doubt that methods (a) and (b) comply with SOLAS requirements, but the stairways in the arrangement of method (c) are not enclosed at each level as required by the 1981 SOLAS Amendments. The arrangements shown in Figure 4.1(b) and (c) do not afford the same degree of protection as that provided by the method (a), which would afford a much safer means of escape and access for fire parties when corridors are filled with smoke or toxic gases (Noble, 1985).

On passenger ships the protection of stairways is very important. Method (c) should not be used in accommodation and service areas. Although all three methods are accepted by MSC, the ship designers should choose the safest way: method (a).

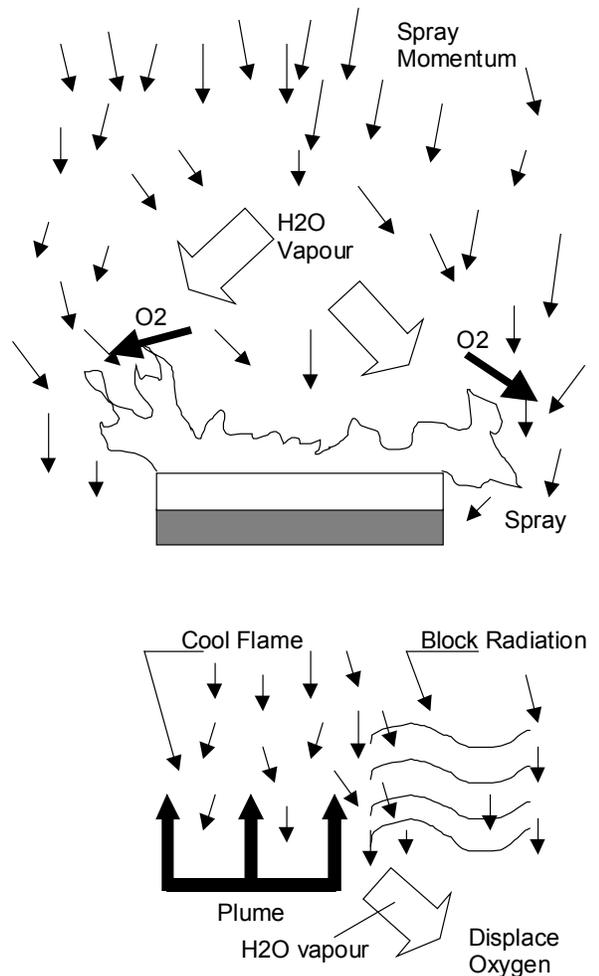
Figure 6.1 Three mechanisms of extinguishing

function. Figure 6.1 illustrates the following three major functions that must be considered in the design of a water mist system (Mawhinney, 1994):

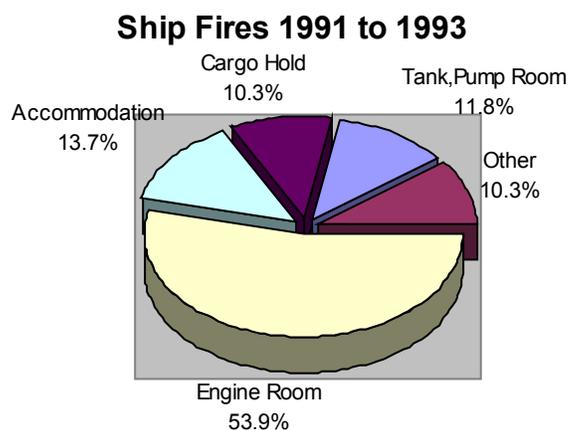
Figure 7.1

Continuing to the analysis of ship fires in Chapter 2, it was recognized that engine room fires got the highest rank sorted by location. A detailed analysis has been undertaken of fires in engine rooms which occurred during the period 1991 to 1993. Figure 7.1* shows engine room fires accounted for almost 54% of all fires occurring between 1991 and 1993. The study of these incidents reveal that they were often initiated by explosion, or result from an uncontrolled release of flammable vapours or fuel into the engine room.

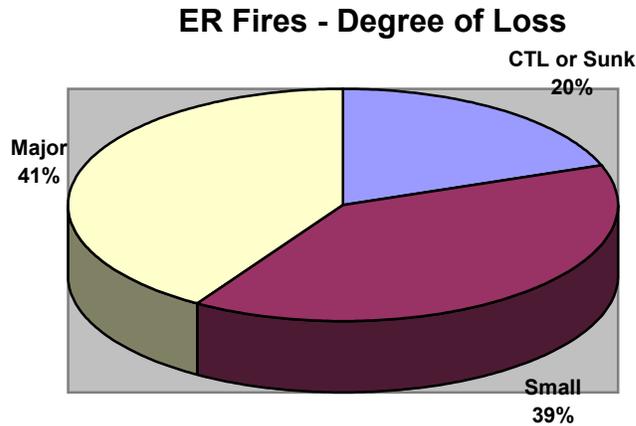
Figure 7.2 shows the degree of loss which resulted from engine room fires in the period, grouped by sinking or constructive total loss (CTL), major fires and small incidents. Over 60% of the engine room fires cause major damage to the ship.

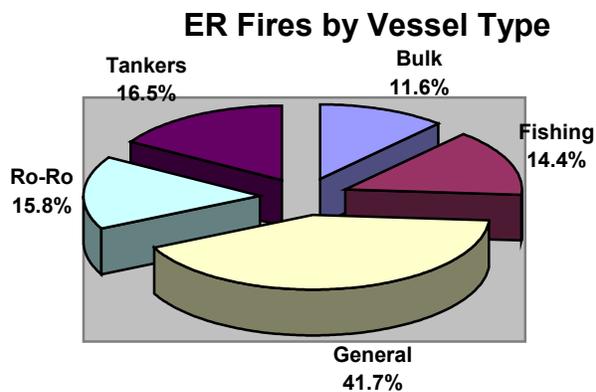
Figure 7.3 groups engine room fires by the type of vessel upon which they had occurred. About 42% of all engine room fires occurred on general cargo ships, 16.5% on tankers and 15.8% on ro-ro vessels.

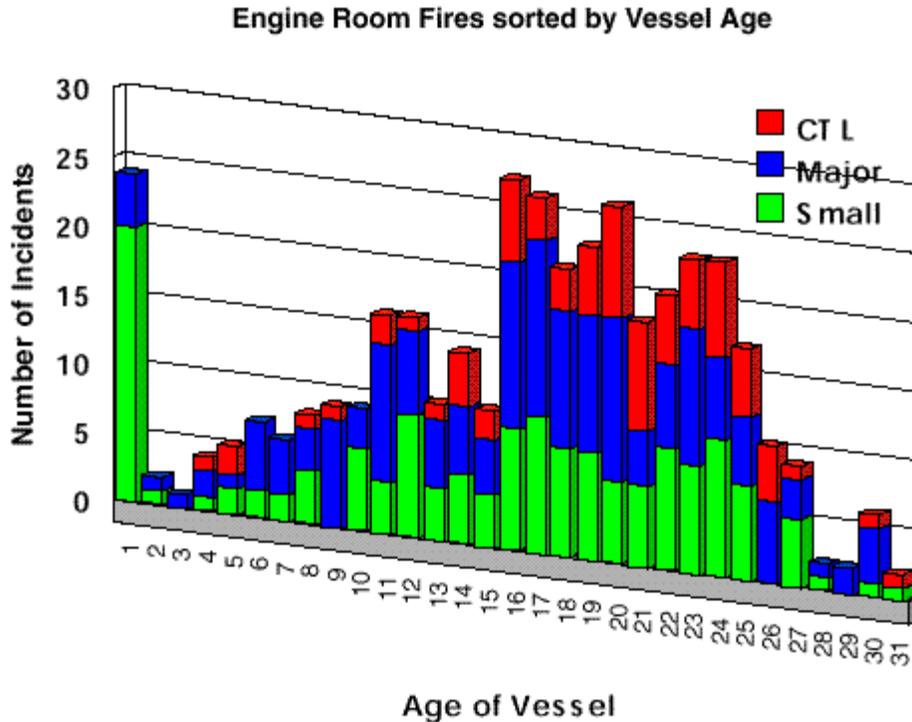
Figure 7.4 shows the incidence of fire grouped by severity and sorted by vessel age. There are a considerable number of incidents during the vessel's first year. Except the first year, the peak of incidents happened in the period of year 16 to year 24.

Taking engine room fires as an example, there is a tremendously large number of fires occurred in the vessel's first year (see Figure 7.4). One of the reasons is that the crew are not familiar with the ship equipment and fire-fighting procedures on board a

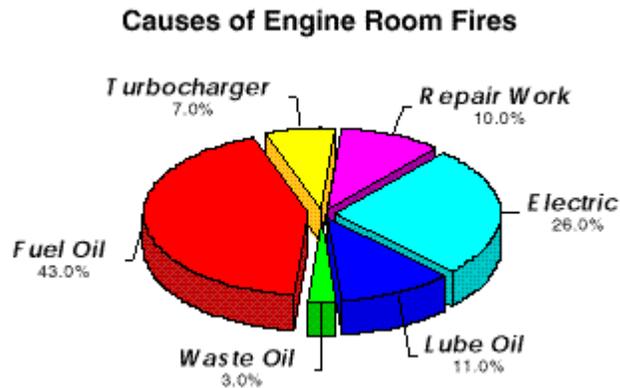
In 1994, the Japanese Classification Society NKK published the results of an investigation into 73 fires which occurred on ships of its class in the period of 1980 to 1992. Figure 7.5 shows the causes of the engine room fires and that 57% involved the release of either fuel, lubricate oil or waste oil, 26% resulted from electrical defect, 10% from repair work, welding and the like.

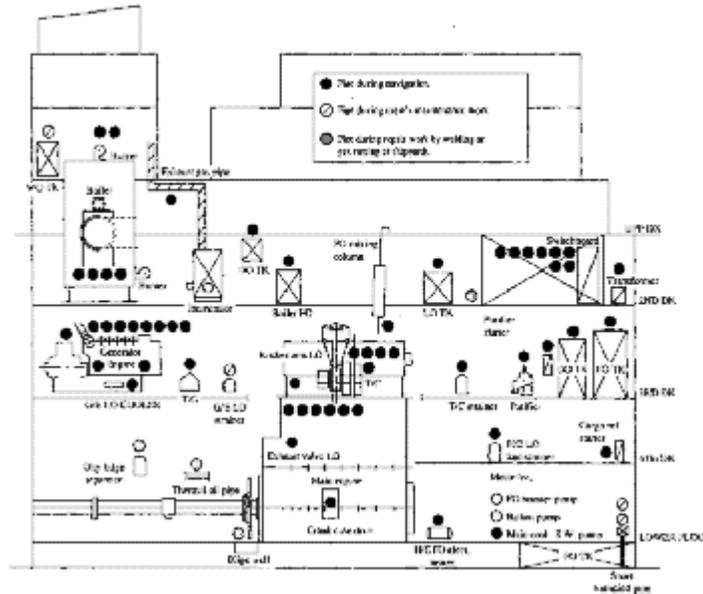
Figure 7.6 The sources of fire in engine rooms

Figure 7.6 shows the sources of engine room fires plotted against the equipment's where they have occurred. The majorities were around the main engine and the generators, while a large number of fires occur near boilers and the electrical switchboard.

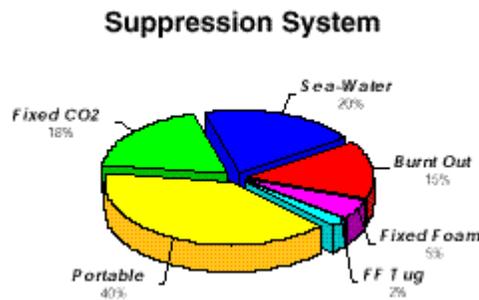
Figure 7.7 gives an idea of how the fires were suppressed. About 40% of all fires in engine rooms were extinguished by portable appliances, 20% by sea water, 18% by fixed CO2 and 5% by fixed foam. The other 15% of fires burn themselves out.

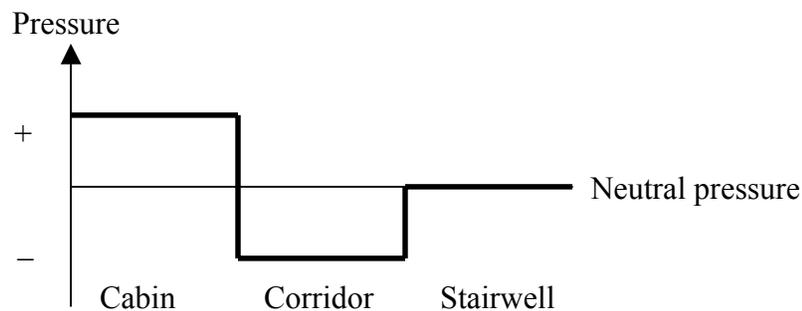
Figure 7.8 Pressure conditions during normal operation

In the traditional HVAC system, air supply to a cabin comes from an air terminal device which is normally located in the ceiling. There is a smaller positive pressure in the cabins in order to prevent the smoke from entering the cabins. Discharge of air normally takes place partly through bathroom and partly to corridor. There are several air terminal units for exhaust in the corridors, therefore the pressure in the corridor is negative.

In halls and stairwells, the air volume supplied is equal to the air volume exhausted. It is a balanced system, and there is no positive or negative pressure in these areas. The conditions of pressure in cabin, corridor and stairwell are shown in Figure 7.8.

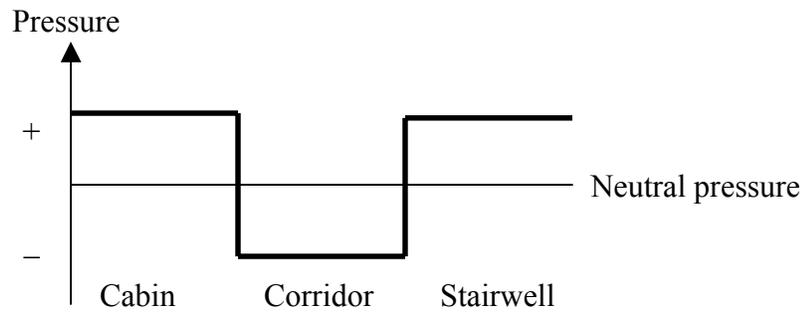
Figure 7.9 Pressure conditions during smoke control mode

Figure 7.9 shows the conditions of pressure where a smoke control system is used. Several full-scale tests have been carried out successfully according to the smoke control philosophy above (Jensen, 1994).
