## An empirical study on the need for anchor operation education and training

**AN EMPIRICAL STUDY ON THE NEED FOR  
ANCHOR OPERATION  
EDUCATION AND TRAINING**

**(MARITIME EDUCATION AND TRAINING)**

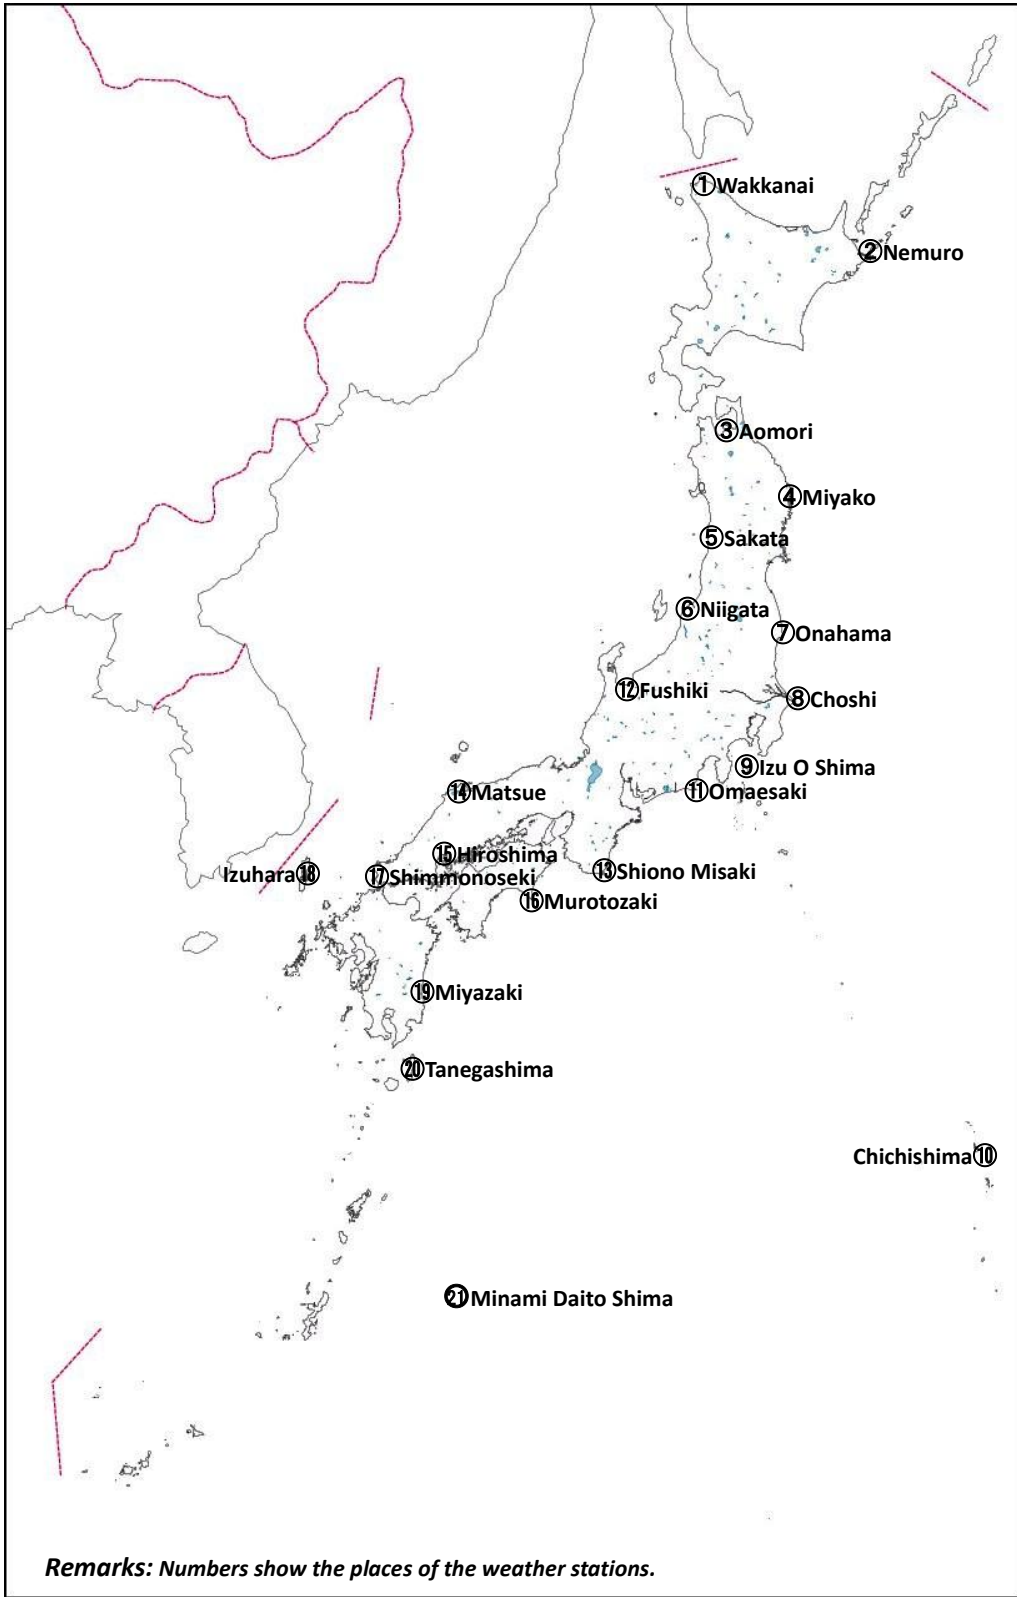
**Fig. 1** Distribution of the sampling weather stations, Japan

The Japan Meteorological Agency publishes the weather statistics on its web site (<http://www.jma.go.jp>). According to the data, the statistics on peak gusts have been collected randomly from several points in Japan. Sampling is mainly from coastal weather stations and covers all regions in Japan as in Fig. 1. Totally, the statistics of 21 points of peak gusts in the year are collected from 1967 to 2009 (some of them are not available) and plotted in the following figures (see Fig. 2, Fig. 3 and Fig. 4). Furthermore, in order to analyze the statistics and to observe the trend, the linearization is overlaid on each figure. To draw linearization on each graph, the Microsoft Excel function was used. As a reference, the raw data is shown in Annex I.

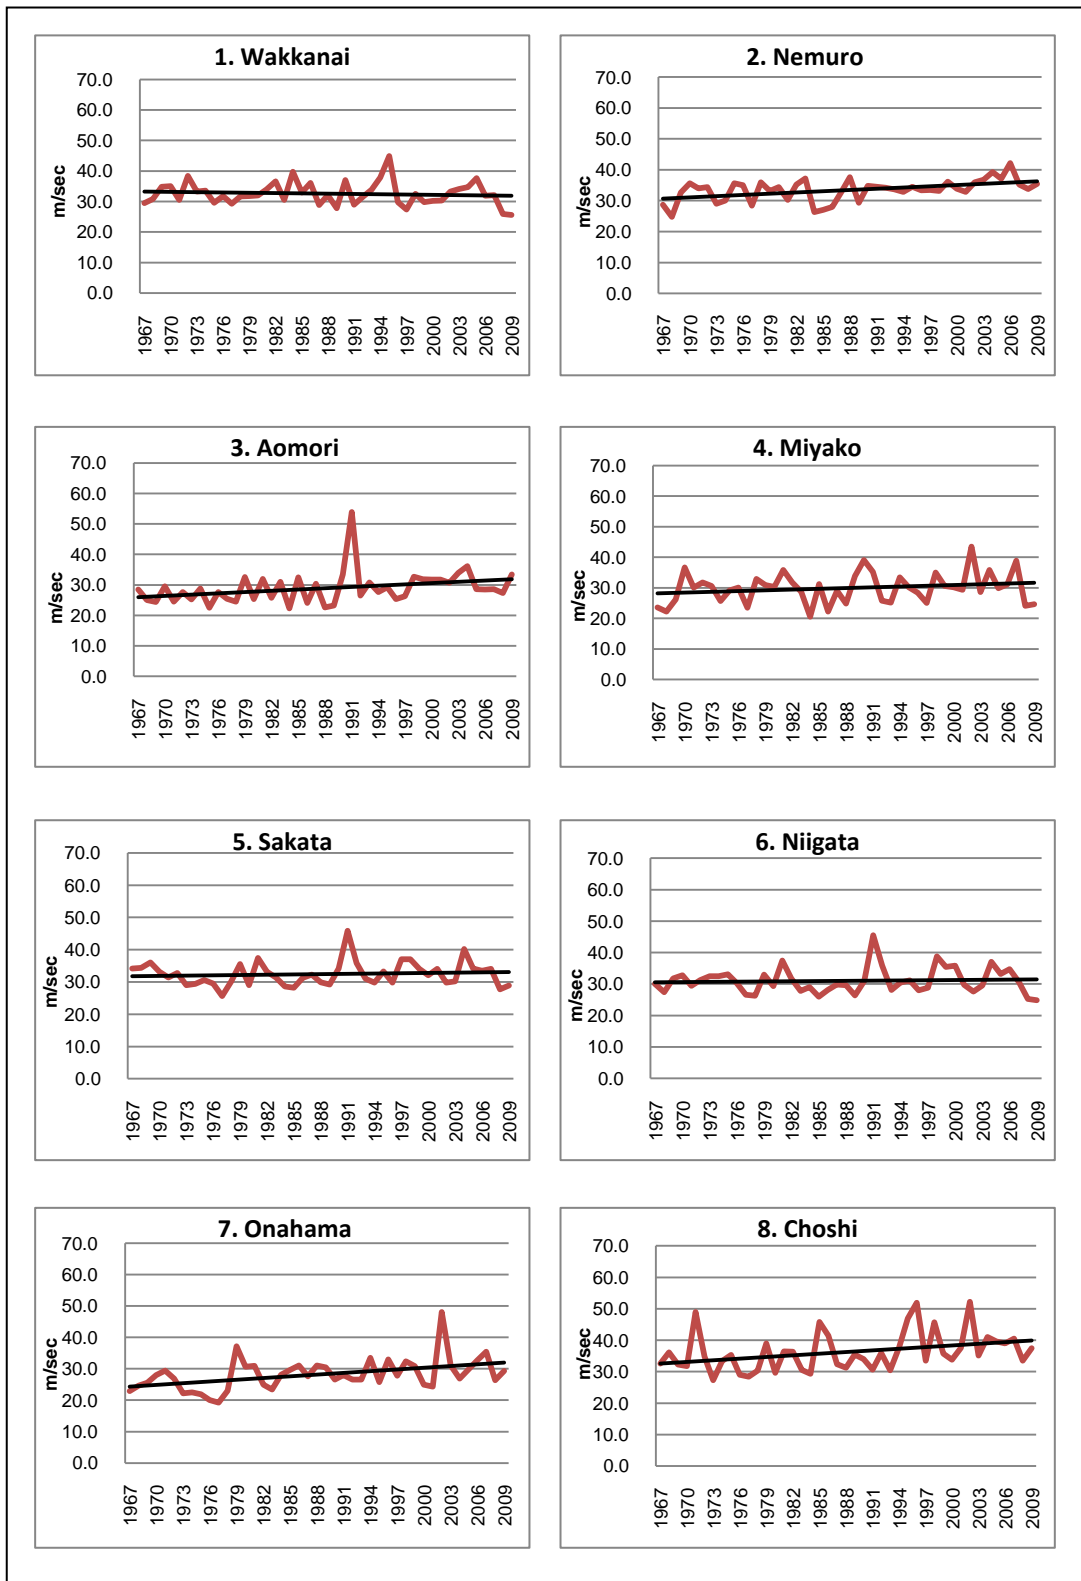
**Fig. 2 Peak gusts at weather stations in Japan from 1967 to 2009 and linearization – part 1**

According to the linearization of the figures mentioned above, at 18 of 21 points the trend of the peak gust is increasing year by year. However, the trend of 3 of 21 points (Murotozaki, Wakkanai and Shimonoseki) has declined. This means the weather condition, especially wind speed, has been getting more severe. There are several areas which have suffered from tropical cyclones. Obviously

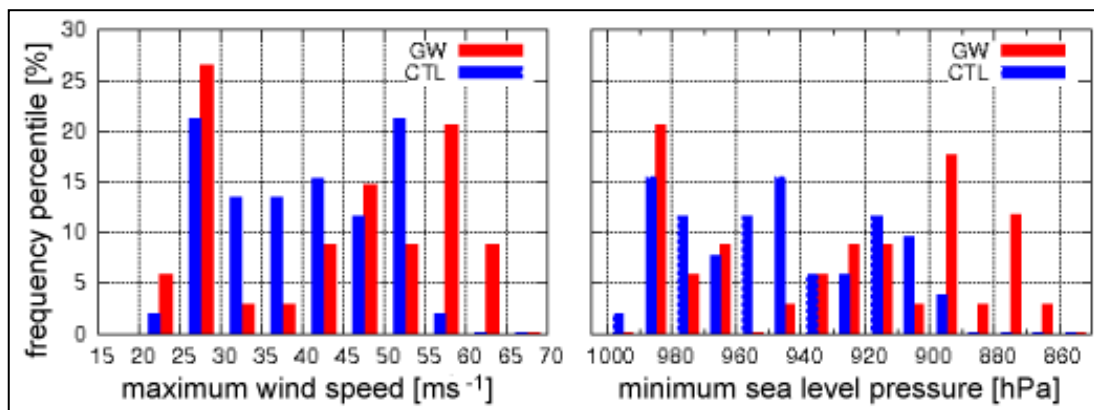
Fig. 5 Comparison between current and future prediction on tropical cyclone

In the future, it is predicted that the frequency percentile of more than 55m/sec in maximum wind speed is approximately 29% compared with approximately 2% in the current situation. In addition, according to the figure on the right, it is found

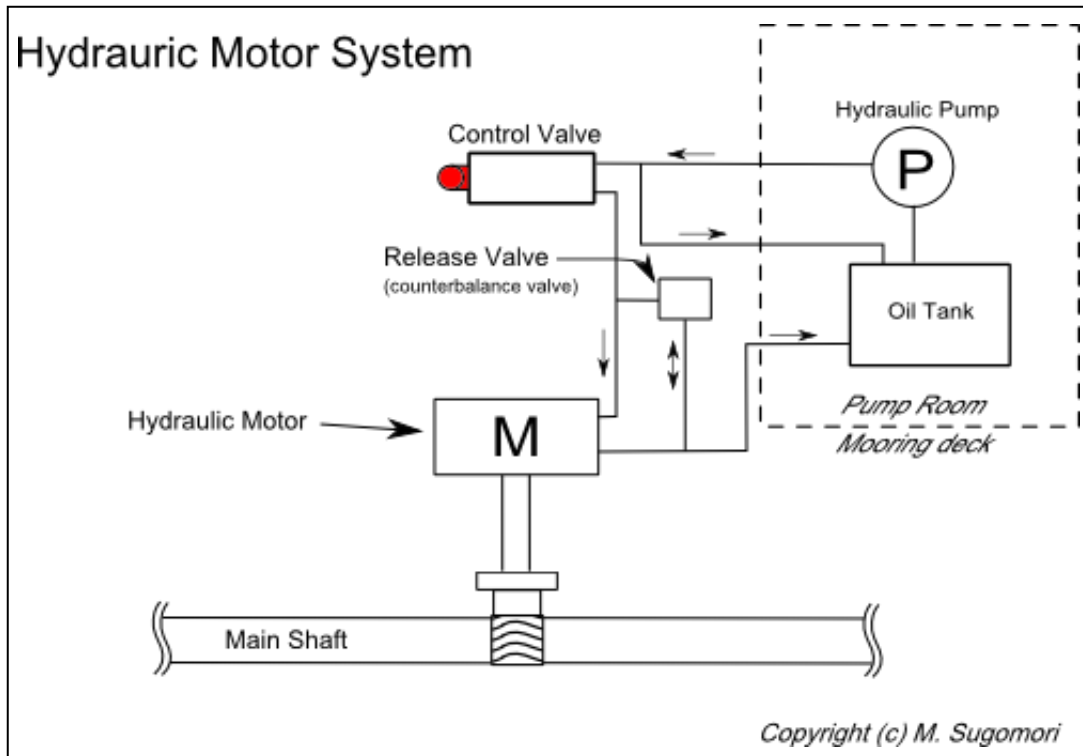
In contrast, this system uses operating hydraulic oil which is pressured by hydraulic oil pumps. The merit of this system is that no matter what the ship's size is, it can be applied. Furthermore, it can prevent the electric spark vicinity of the deck machinery because the hydraulic pumps and oil tank can be located apart from the deck machinery. Fig. 8 shows the drawings of this system. A control lever can control the speed of the winding by changing the flow of hydraulic oil. As a difference, there is a safety device called the Counterbalance valve to release the overload. This is a releasing valve which prevents the rising of the pressure of the hydraulic oil. It is necessary to maintain the settings

**Fig. 8 Hydraulic motor windlass system**

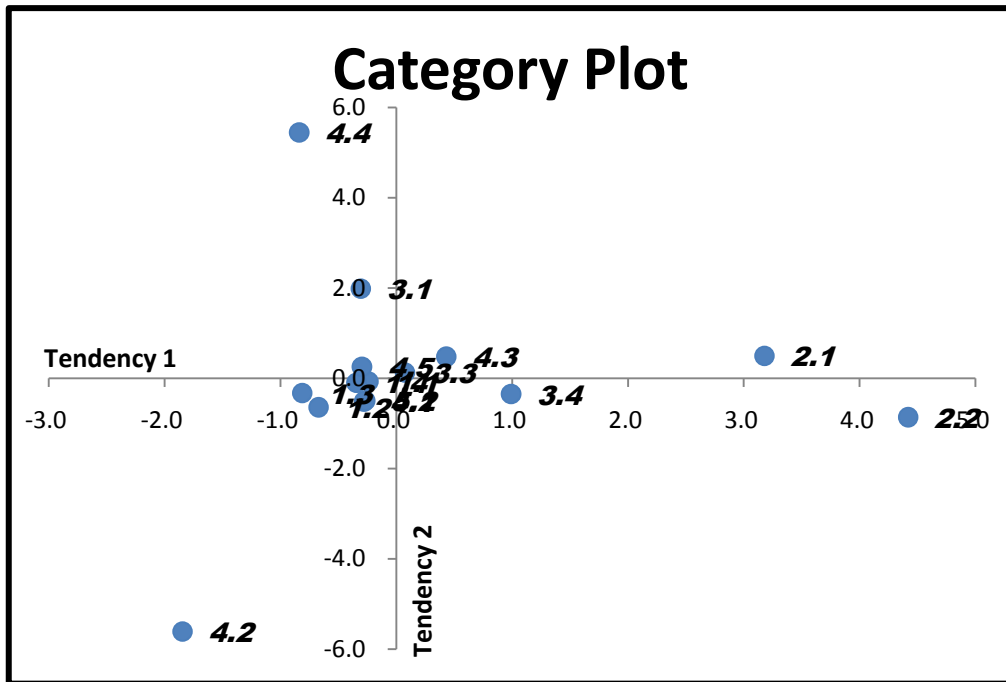
Fig. 11 Category plot from Quantification method type III

Fig. 11 and Fig. 12 show Category plot and Sample plot respectively. Table 9 and Table 10 show the raw data of Category plot and Sample plot respectively. As a characteristic of the quantification method type III, there is the same tendency on each axis of both Category plot and Sample plot (Hasegawa, 2004).

According to Fig. 11 and Fig. 12, Tendency 1 would mean the degree of technical element because '2.2 Lack of maintenance' and '2.1 Defect of design' are plotted at a high score and '4.2 Lack of leadership' is plotted at a low score. In Fig.12 (Sample plot), the accidents on the mechanical failure are plotted at a high score (ix, xxxv, xlvi)

On the other hand, regarding Tendency 2 in Category plot, only '4.4 Ill-preparedness of manuals' is plotted at a high score and only '4.2 Lack of leadership' is plotted at a low score. Although it is difficult to determine the tendency, Tendency 2 would mean the degree of management factor.

According to Fig. 11 and Fig. 12, most of the factors are plotted closely to each other at the center. Here, the center means the score is 0 (zero). The items are plotted near to each other have a strong correlation. Especially in Fig. 11, most of the factors plotted at the center would have a strong correlation.

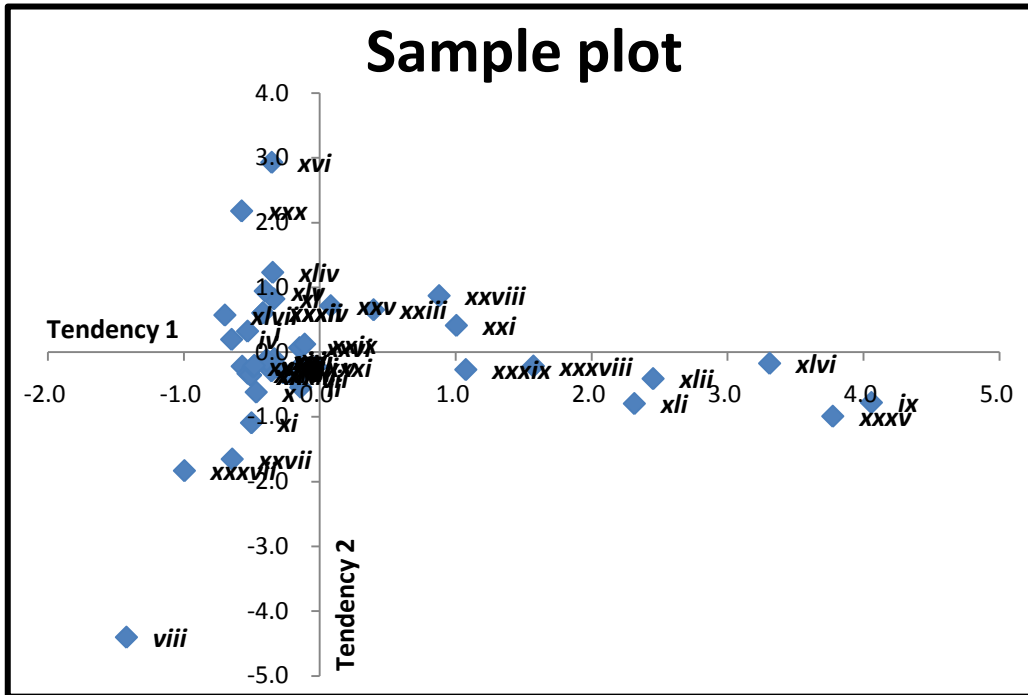
Fig. 12 Sample plot from Quantification method type III
